# Technical Service Bulletin

## 34, 37 Grinding or wheel bearing type noises from front when accelerating or at constant speed

34 12 08 2028650/1 February 21, 2012/

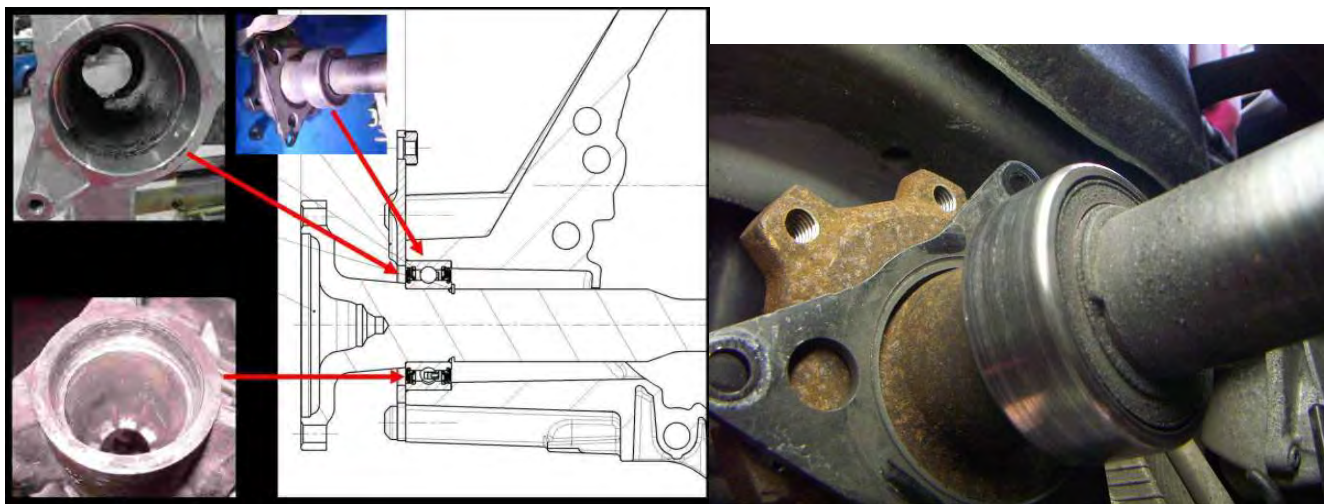
The ball bearing for the left flange shaft spins in the gearbox housing because of a gap between the outer bearing ring and the support bracket.

**Tip:** The affected ball bearings are only fitted on the left side; therefore, the complaints do not occur on the right side.

**Figure 1.** Grinding marks and swarf in gearbox housing, on flange housing, outer race of the bearing and support bracket.

Try to reproduce the customer complaint so that it can be clearly assigned to this TSB by removing the support bracket and checking for wear marks. If wear marks are present as shown in Figure 1 above, follow checks and repair instructions below.

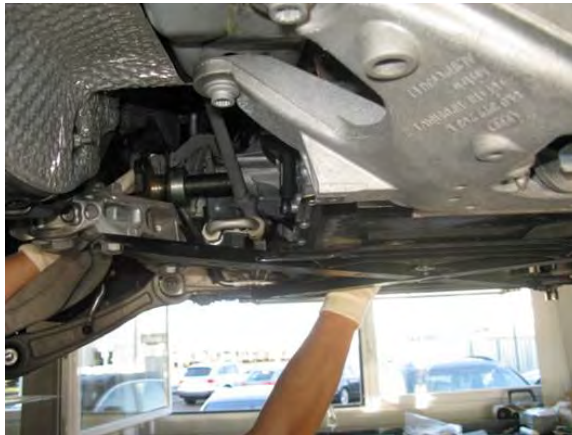
*Figure 2. Supporting the flange shaft.*

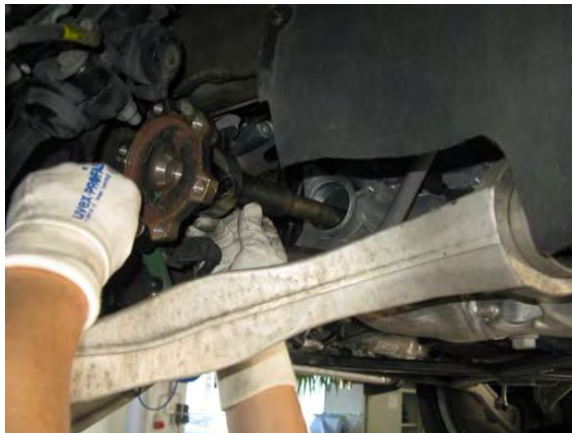
*Figure 3. Pulling out the flange shaft.*

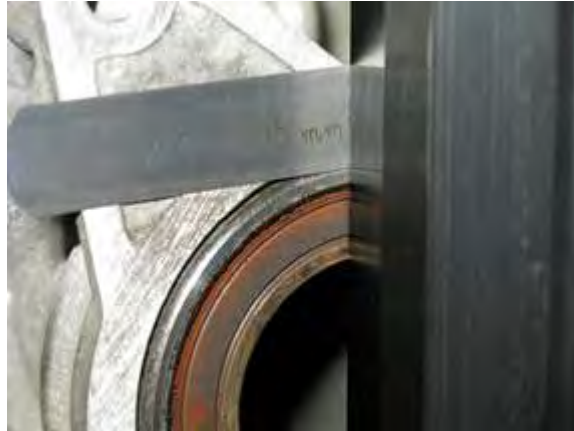
*Figure 4. Bearing example.*

**Tip:** Bearing in Figure 4 is only for demonstration purposes, ALWAYS measure using a new bearing.

1. Determine how many shims must be fitted between bearing and gearbox housing to make the bearing extend out from the case a minimum of 0.5mm to 0.8 mm; each shim is 0.30mm in thickness.

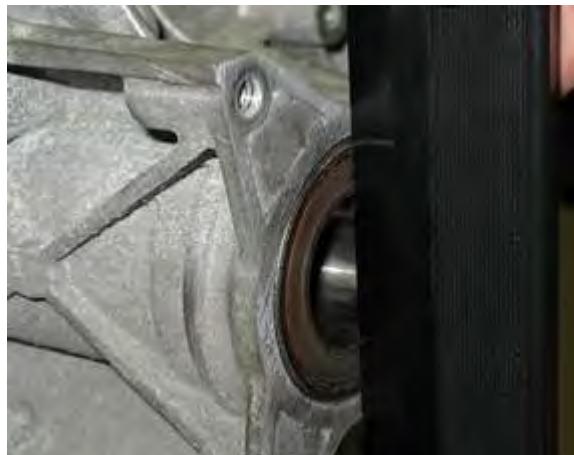
*Figure 5. Apply straightedge on gearbox housing/bearing.*

1. Remove any corrosion or dirt on the gearbox flange surface. Use size 600 grit sandpaper. Do not clean the bearing carrier.
2. Measure whether the gap between bearing and gearbox housing is flush or extended from case.
3. Use a straightedge on two different positions on the bearing and on the gearbox housing (this leads to four measuring positions).

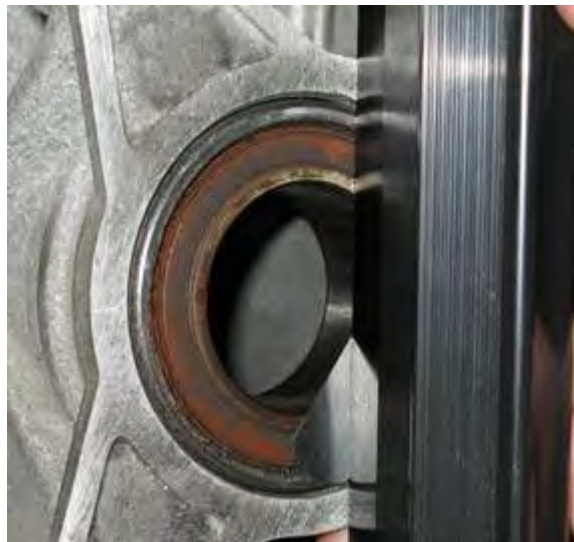
**Tip:** Bearing in Figure 6 is only for demonstration purposes, ALWAYS measure using new bearing.

*Figure 6. Measuring gap*

- After the measuring, calculate how many shims must be fitted between bearing housing and bearing. Examples:

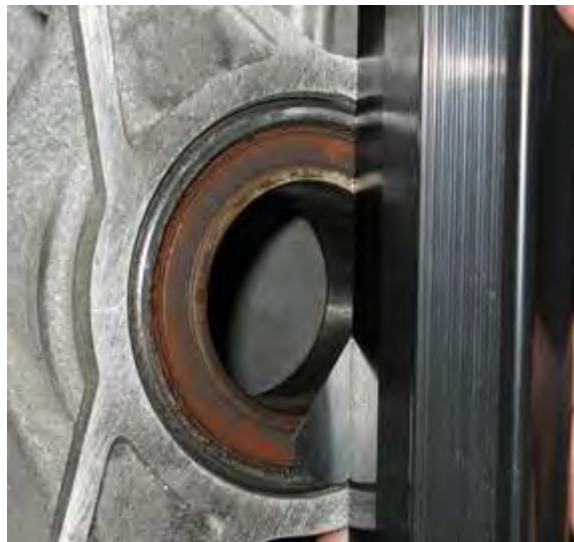
- Measured values: Top 0.10 mm, bottom 0.15 mm, left 0.15 mm, right 0.10 mm  
Biggest measured value: 0.15 mm  
For the calculation the value must be given a negative algebraic sign.

*Figure 7. Determine the below flush value.*

Three shims are needed.

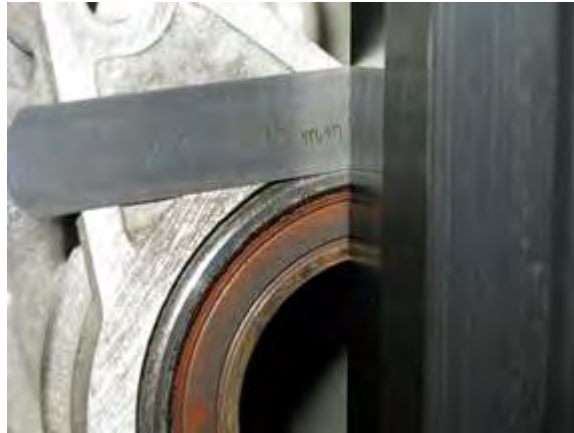
1. Measured values: Top 0.10 mm, bottom 0.15 mm, left 0.10 mm, right 0.10 mm

**Figure 8.** Determine the extended value.

Two shims are needed.

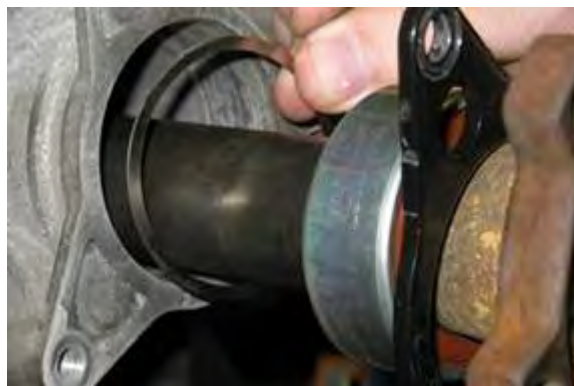
**Figure 9.** Position of shims.

2. Clean the flange shaft with a fluff-free cloth and slightly lube the shaft at the seal contact area using **G 052 128 A1**.
3. Install the shims as shown below and feed the shaft back through the opening of the lower gearbox side with appropriate support taking care not to damage the seal.
4. Be sure to replace the support bracket bolts.

Because the bearing turns, it may have taken material off of the bearing carrier in axial and radial direction. The resulting free play can be ignored, as a turning of the outer bearing ring is prevented by the axial clamping force of the support bracket.
