## SK®400

The 400 has proven to be very reliable transmission. It is a real performer. It's ruggedness allows it to continue to operate for many miles with smooth even shifts.

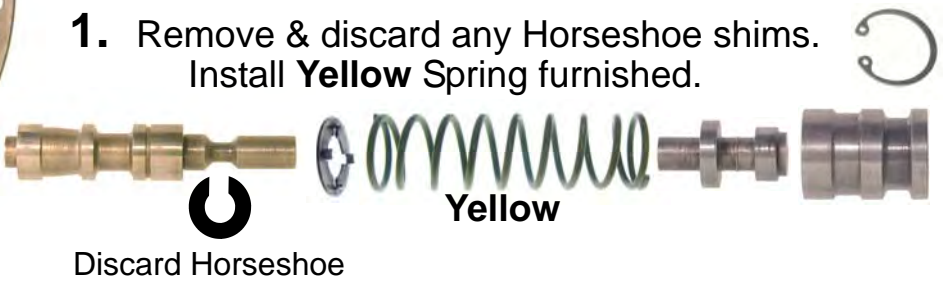
1. Remove & discard any Horseshoe shims. Install **Yellow** Spring furnished.

Discard Horseshoe

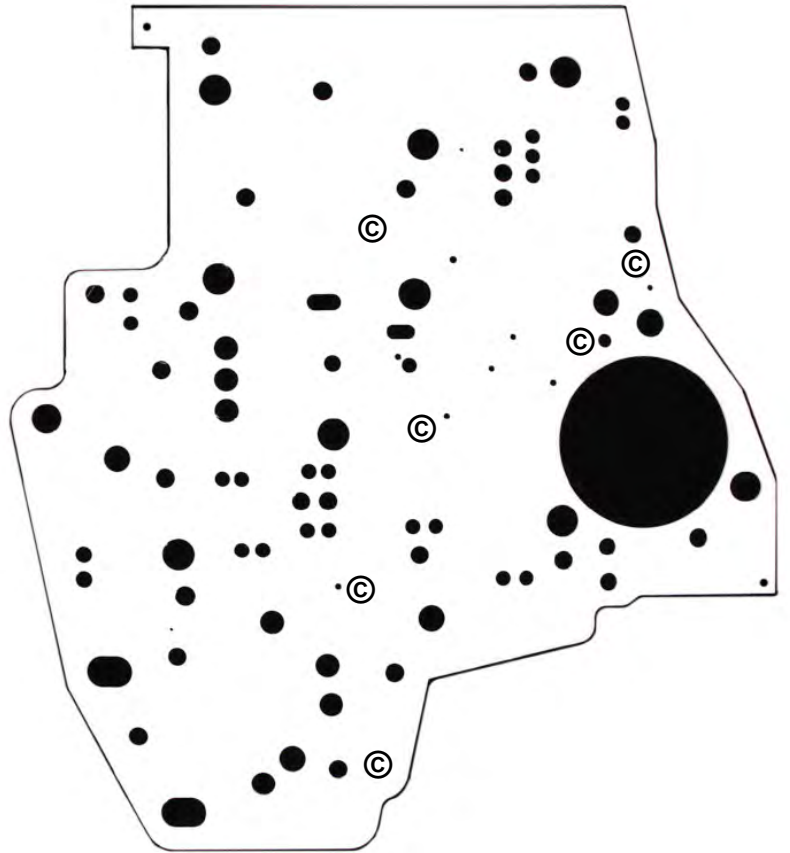
1. Install **Blue** Spring here

2-3 Shift Valve

VB

New SK<sup>®</sup> plate produces short smooth shifts. This product is not for making firm Hi-Perf type of shifts. If you want firm shifts and complete gear control order TransGo Reprogramming Kit.

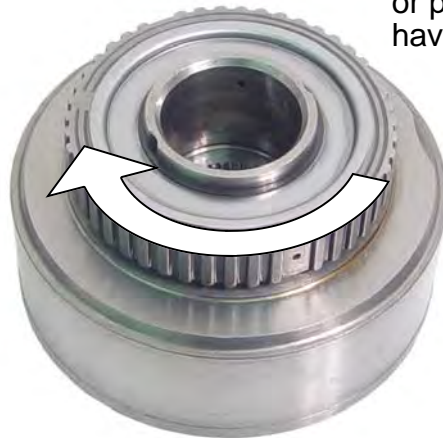
Plastic accumulator pistons break. Order Aluminum.

Direct Drum or piston must have check ball.

Intermediate Sprag  
Outer race must freewheel  
as shown

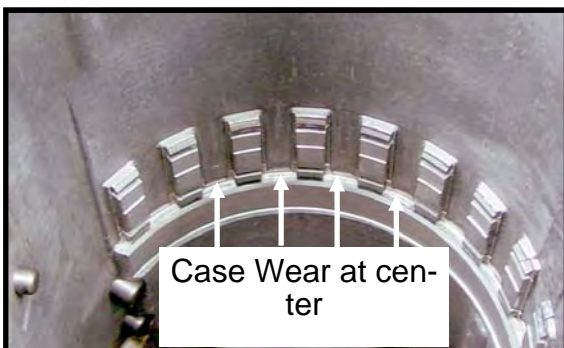
**Case Wear:** This case wear problem that has driven many a good man right up the wall. Wear at this point allows excessive center support movement and misalignment. This can cause high clutch failure, late or no 2-3 shift, falls out of high when hot; center support bushing wear, front planet wear and stator support failure. Only use center support that uses a steel shim in the case under the support.
